**ALABAMA HAZARDOUS WASTES MANAGEMENT AND MINIMIZATION ACT (AHWMMA)  
COMPLIANCE EVALUATION INSPECTION (CEI) REPORT**

Valmont Coatings Inc. d/b/a Valmont Birmingham Galvanizing (Valmont)  
475 Dietrich Road  
Steele (St. Clair County), AL 35987

June 24, 2019

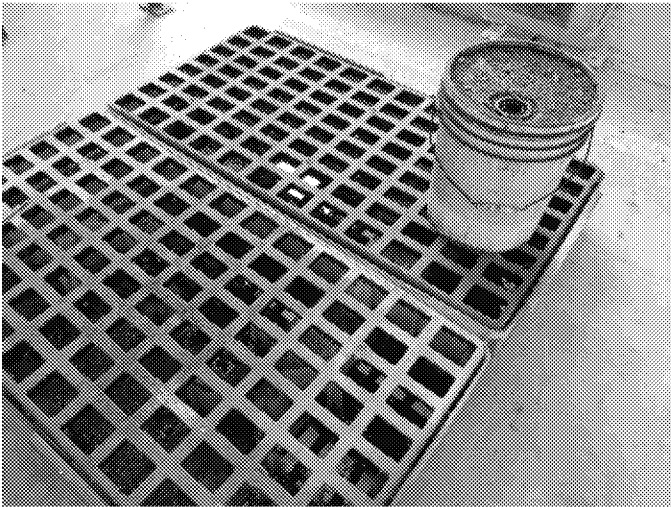
Mr. Cunningham and Mr. McDonough first escorted us on a tour of the non-Valmont product processing / storage area, which occupies the northwestern portion of the production area. The facility's central hazardous waste accumulation area (CAA) was located in the northern portion of this area, near a receiving dock. The CAA was separated from the rest of the production floor by a waist-high chain. One plastic 5-gallon bucket of used oil was staged on a plastic spill control pallet in the CAA at the time of the inspection. The bucket was open and unlabeled (refer to Photograph #1 through Photograph #3 in the attached photo

log). The spill control pallet also contained used oil. It, too, was open and unlabeled. No hazardous wastes were staged within the CAA at the time of the inspection. Forty four open-top metal 55-gallon drums containing burnt skins (unusable materials removed from the MZR) were staged near the CAA. The containers were open and unlabeled (see Photograph #4).

- Two containers (one 5-gallon bucket and one plastic spill control pallet) holding used oil were not closed;
- Two containers (one 5-gallon bucket and one plastic spill control pallet) holding used oil were not labeled with the words "Used Oil";

Photograph #1: open, unlabeled containers of used oil in the CAA

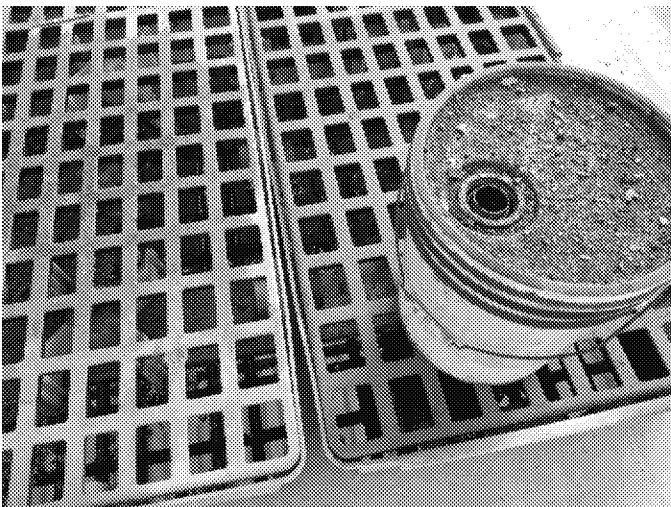
Photograph #2: open, unlabeled containers of used oil in the CAA

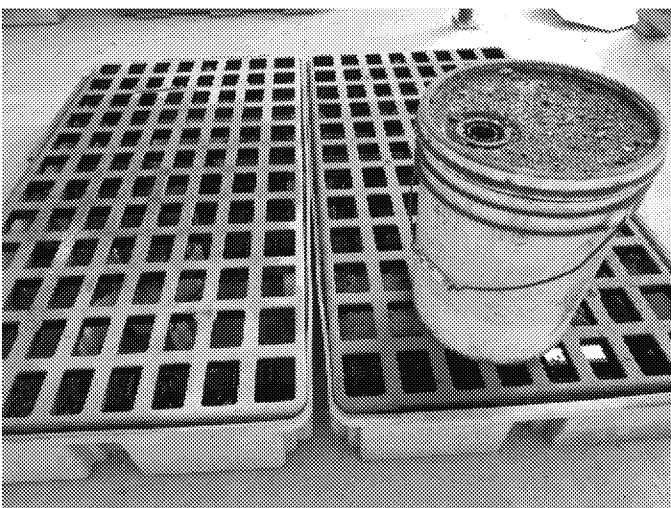
Photograph #3: open, unlabeled containers of used oil in the CAA

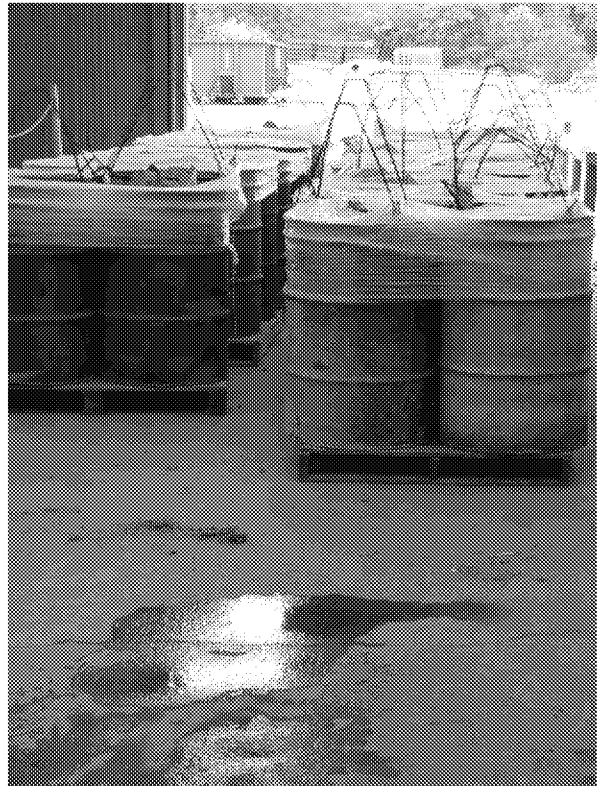
Photograph #4: containers of "burnt skins" near the CAA

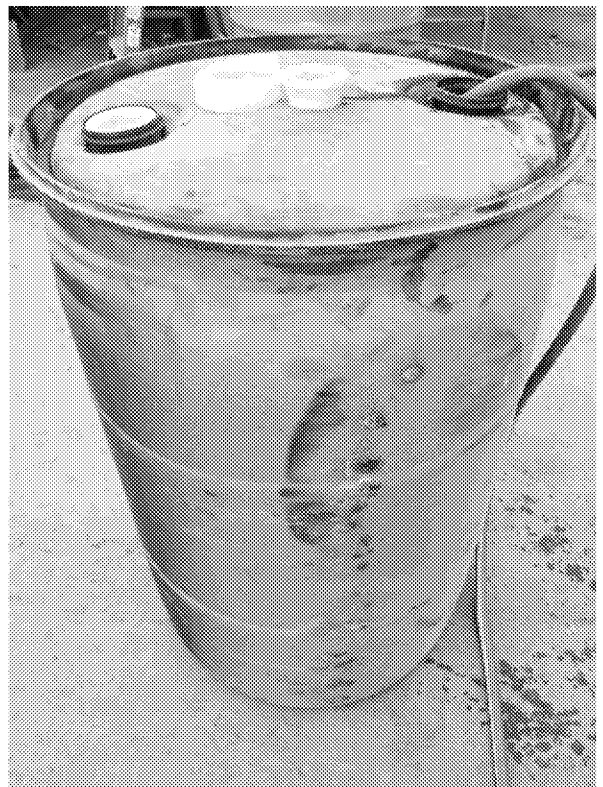
One wheel abrader machine (which is used instead of a caustic solution to clean some parts) was located near the CAA. One open, unlabeled open-top metal 55-gallon drum containing used blast media was staged next to the wheel abrader. According to Mr. Cunningham and Mr. McDonough, the blast media will be reused on-site. One open, unlabeled closed-top plastic 55-gallon drum was also staged near the wheel abrader (see Photograph #5). According to Mr. Cunningham and Mr. McDonough, the drum contained water contaminated with mud and diesel sludge. They stated that a small amount of mud and diesel sludge was generated when facility personnel moved a diesel fuel storage tank into the building. The mud and sludge were washed into a sump located in the receiving dock and subsequently pumped from the sump into the abovementioned drum (see Photograph #6 and Photograph #7). Waste was being added to the drum (via a hose inserted into the drum's bung hole) at the time of the inspection. According to Mr. Cunningham and Mr. McDonough, a waste determination had not yet been performed on the material.

- A waste determination had not been performed on one 55-gallon drum of diesel-contaminated water;
- With one exception (a weekly inspection log dated January 29, 2019), records of weekly inspections of the facility's CAA after December 21, 2018 were not available for review;

Photograph #5: unlabeled container of diesel-contaminated water near the CAA

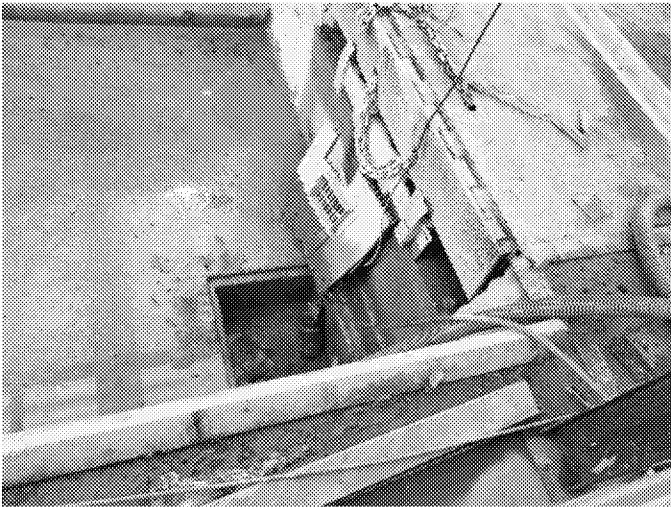
Photograph #6: sump containing diesel-contaminated water

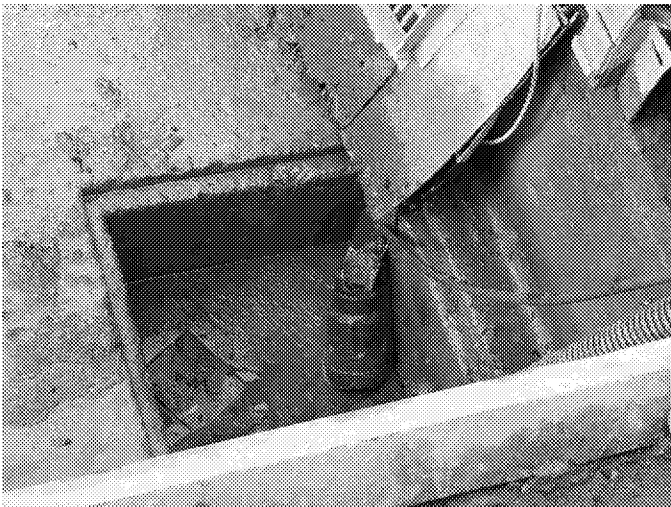
Photograph #7: sump containing diesel-contaminated water

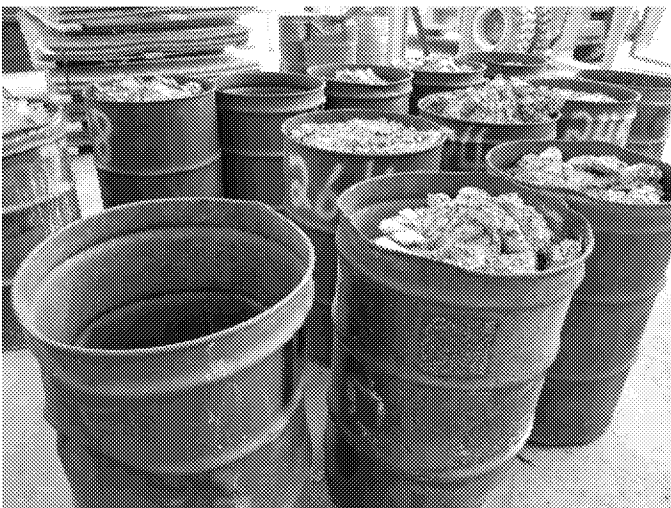
Thirteen open-top metal 55-gallon drums containing zinc dross were staged near the northern end of the galvanizing area. The containers were open and unlabeled (see Photograph #8). One open-top metal 55-gallon drum of burnt skins was also staged in this area. It, too, was open and unlabeled (see Photograph #9). One metal pot containing unprocessed zinc skins was staged near the zinc bath on the Main Line (see Photograph #10). It was open and unlabeled. Valmont's MZR machine was located on the south side of the galvanizing area. Four open-top metal 55-gallon drums containing zinc dross was staged near the MZR. The drums were open and unlabeled (see Photograph #11).

Photograph #8: containers of zinc dross in the galvanizing area

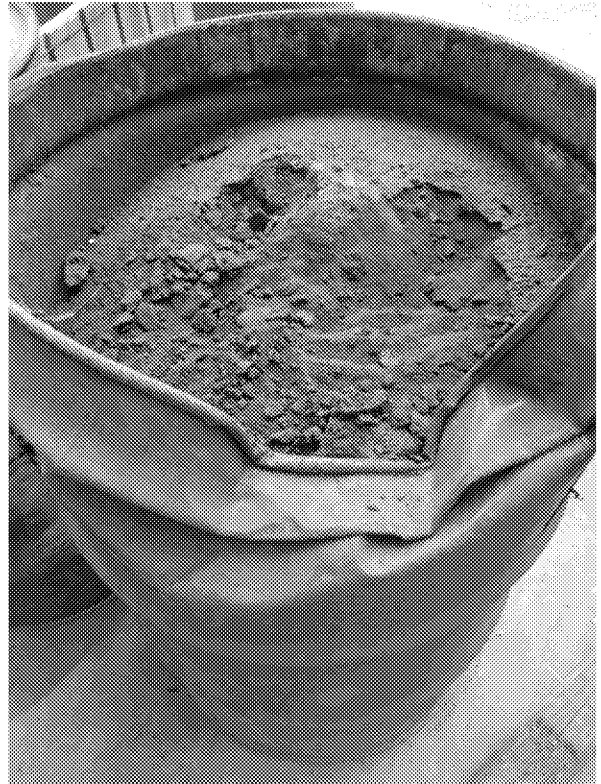
Photograph #9: container of "burnt skins" in the galvanizing area

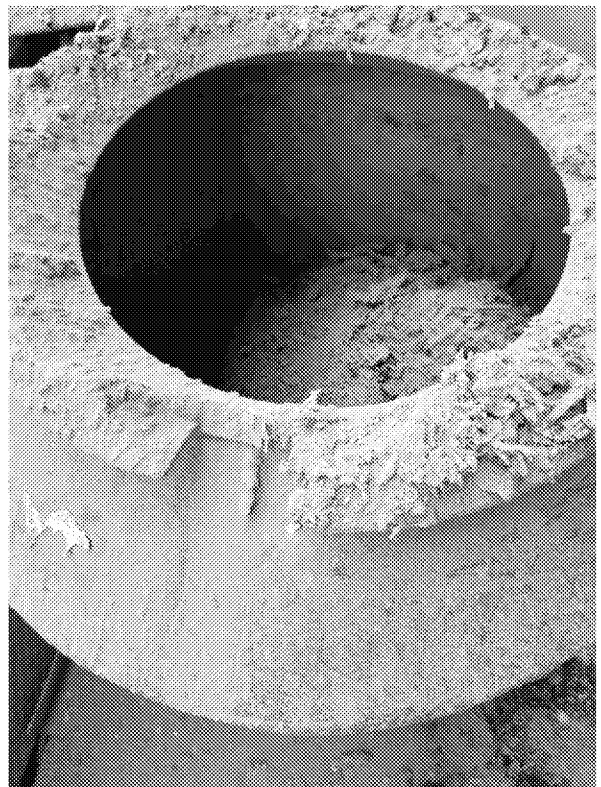
Photograph #10: pot of zinc skins in the galvanizing area

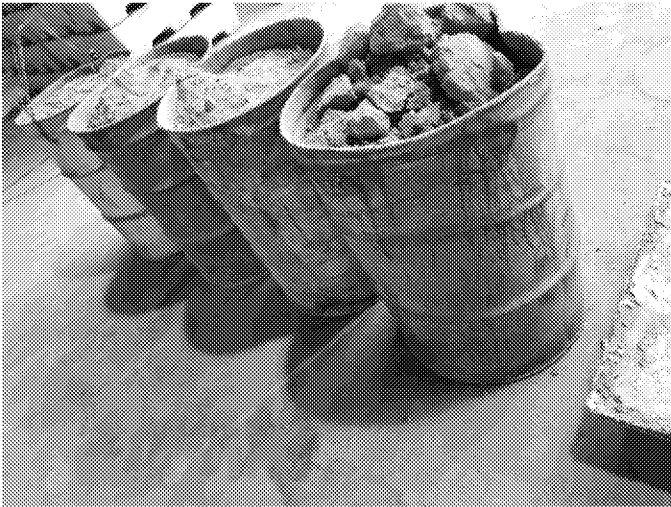
Photograph #11: containers of zinc dross in the galvanizing area

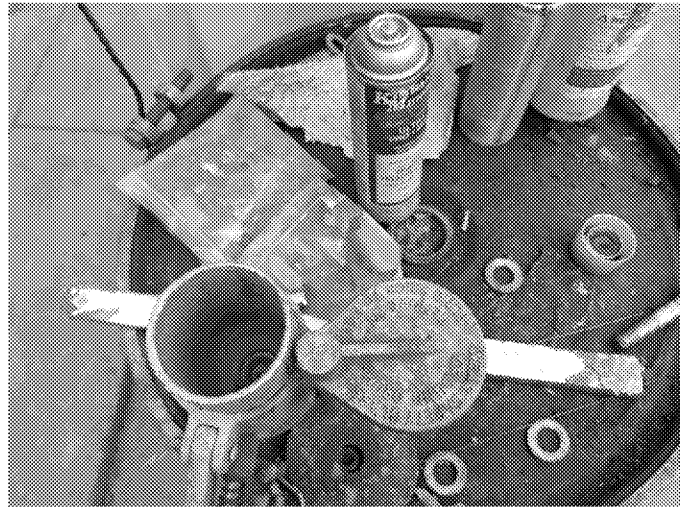
Photograph #13: aerosol can puncture station in the Valmont product processing / storage area

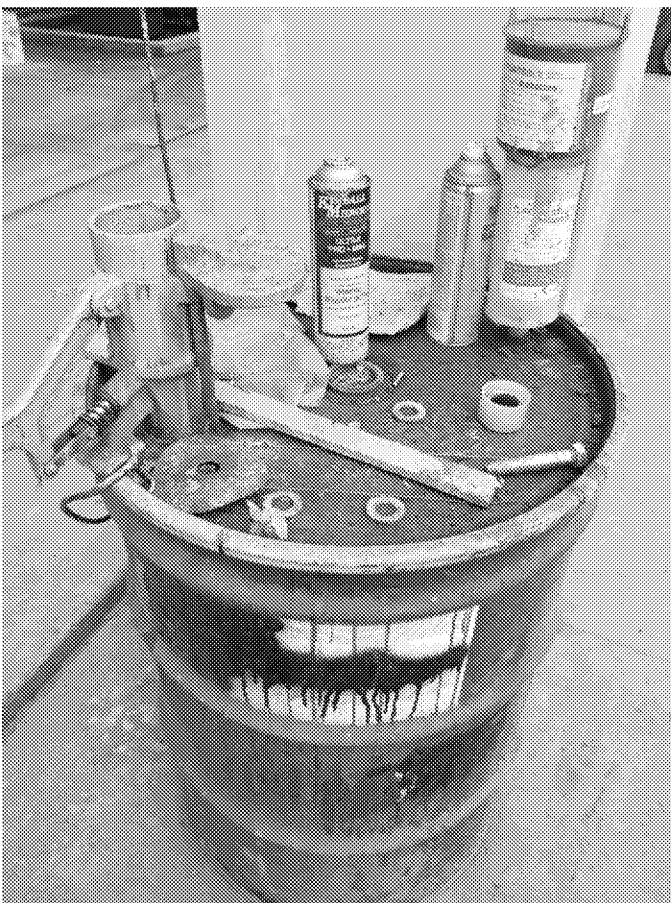
Photograph #12: aerosol can puncture station in the Valmont product processing / storage area

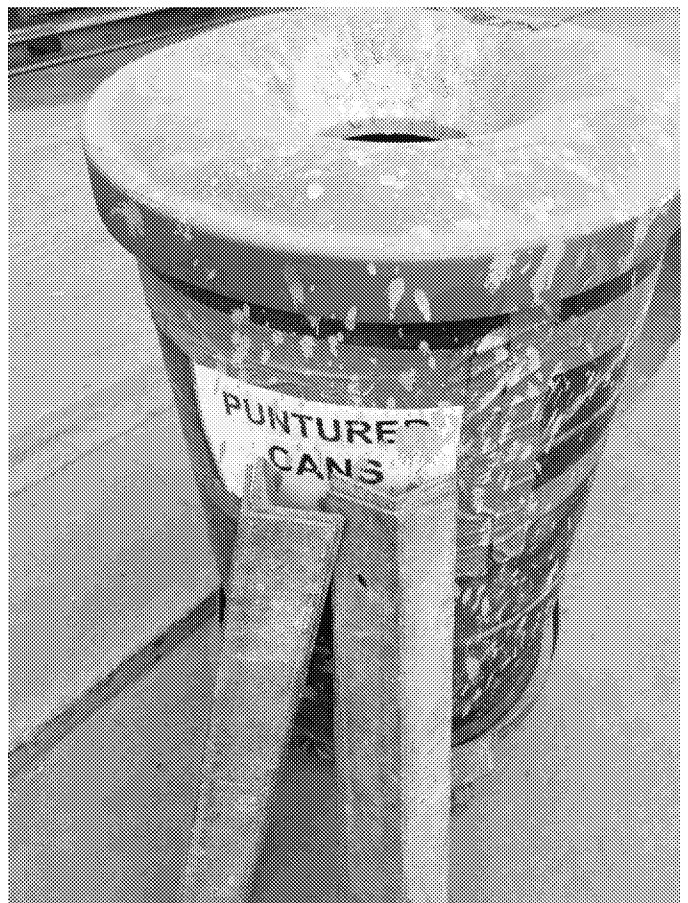
Photograph #14: container of punctured aerosol cans in the Valmont product processing / storage area

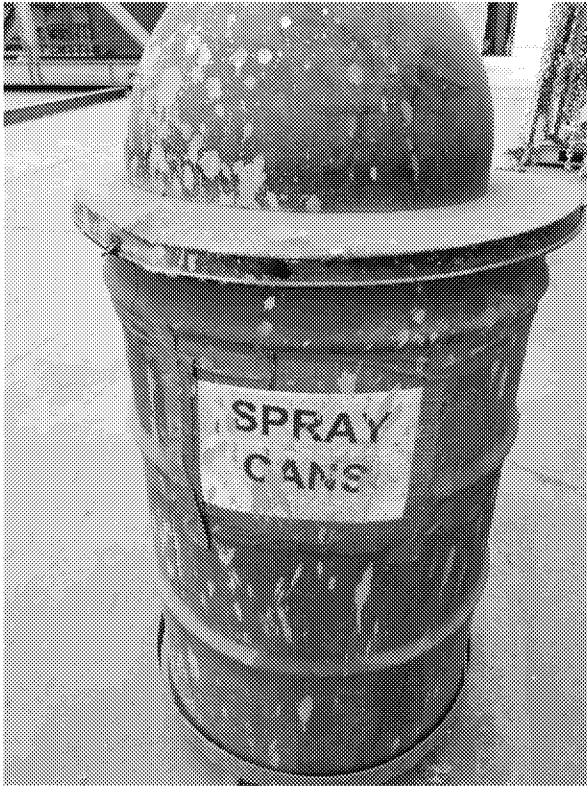
Photograph #15: container of punctured aerosol cans in the Valmont product processing / storage area

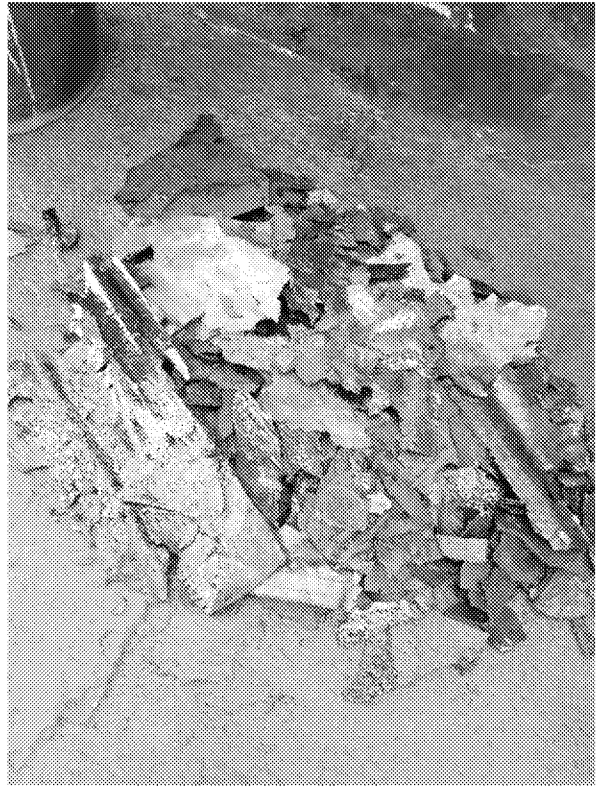
Photograph #17: floor scrapings generated in the painting area

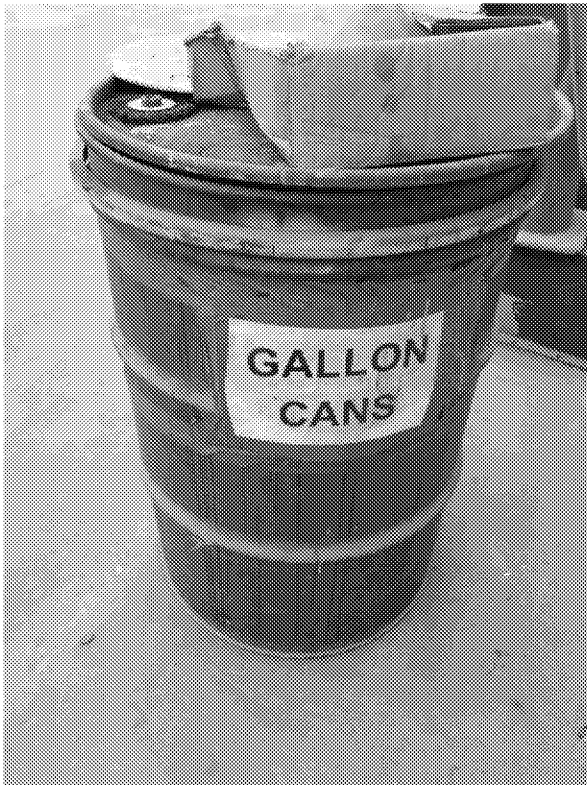
Mr. Cunningham and Mr. McDonough next accompanied us on a tour of the Valmont product processing / storage area, which occupies the southeastern portion of the production area. One can puncture station (a closed-top metal 55-gallon drum with a can puncture unit screwed into its large bung hole and an air filter screwed into its small bung hole) was staged in this area. The container was open (the lid on the can puncture unit was not closed) and unlabeled (see Photograph #12 and Photograph #13). Two open-top metal 55-gallon drums containing punctured aerosol cans were staged next to the can puncture station. One was open and labeled with the words "Punctured Cans" (see Photograph #14). One was closed and labeled with the words "Spray Cans" (see Photograph #15). One open-top metal 55-gallon drum containing empty paint cans was also staged in this area. The container was open (its lid was not secured) and labeled with the words "Gallon Cans" (see Photograph #16).

Photograph #16: container of empty paint cans in the Valmont product processing / storage area

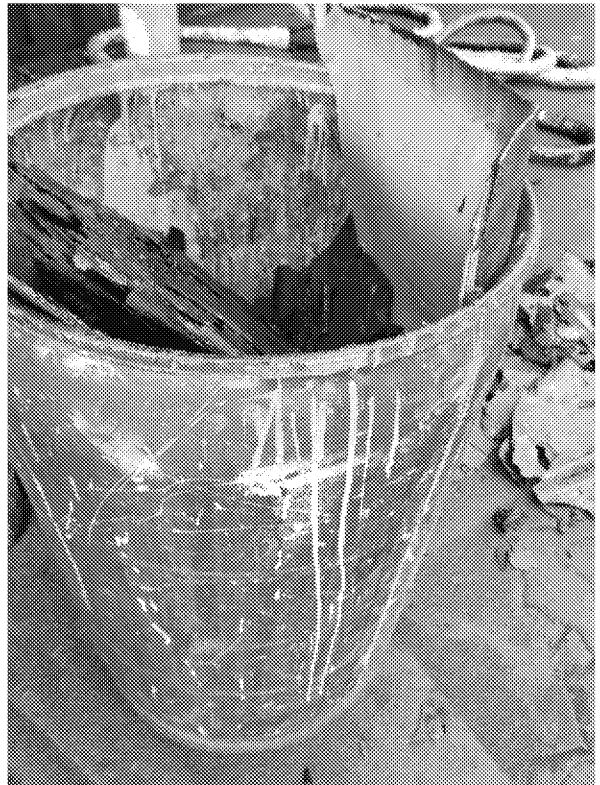
Photograph #18: floor scrapings generated in the painting area

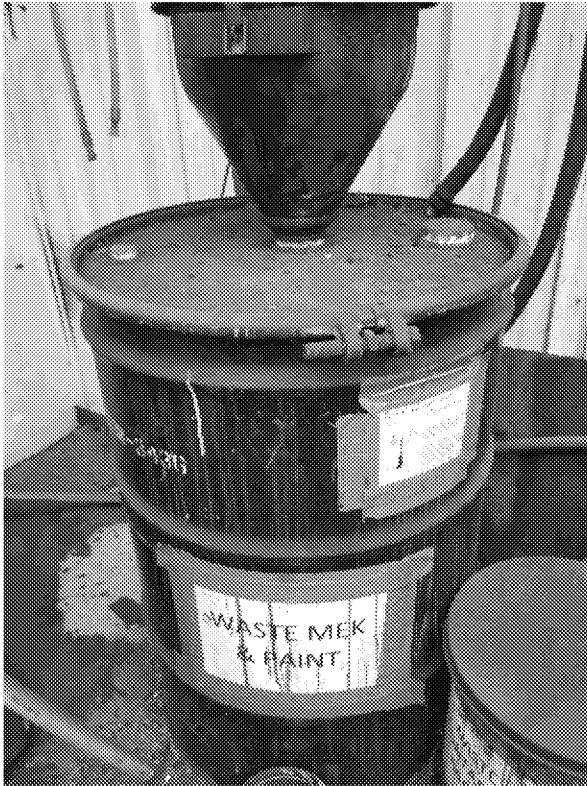
- One open-top metal 55-gallon drum of used MEK that was open (a lidded metal funnel was screwed into the drum's bung hole but the lid on the funnel was not secured) and labeled with the words "Waste MEK & Paint" (see Photograph #19);
- One 5-gallon metal step can of MEK-contaminated rags and PPE that was closed, labeled with the words "Waste MEK Contaminated Rags & Wipes", and labeled with a "Flammable Solid" placard (see Photograph #20); and
- One plastic 0.5-gallon cup of used MEK that was open and unlabeled (see Photograph #21).

- Two satellite accumulation containers of hazardous waste (one 55-gallon drum of waste MEK and one 0.5g-gallon cup of waste MEK) were not closed;
- Three satellite accumulation containers of hazardous waste (one 55-gallon drum of waste MEK, one 5-gallon step can of MEK-contaminated rags and PPE, and one 0.5g-gallon cup of waste MEK) were not labeled with the words "Hazardous Waste";

Photograph #19: open, improperly labeled satellite accumulation container in the paint mixing room

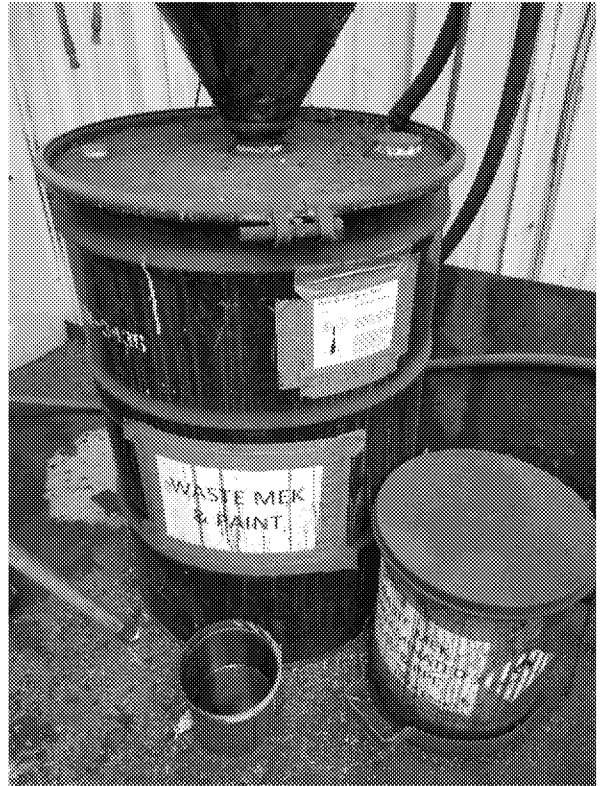
Photograph #21: open, improperly labeled satellite accumulation container in the paint mixing room

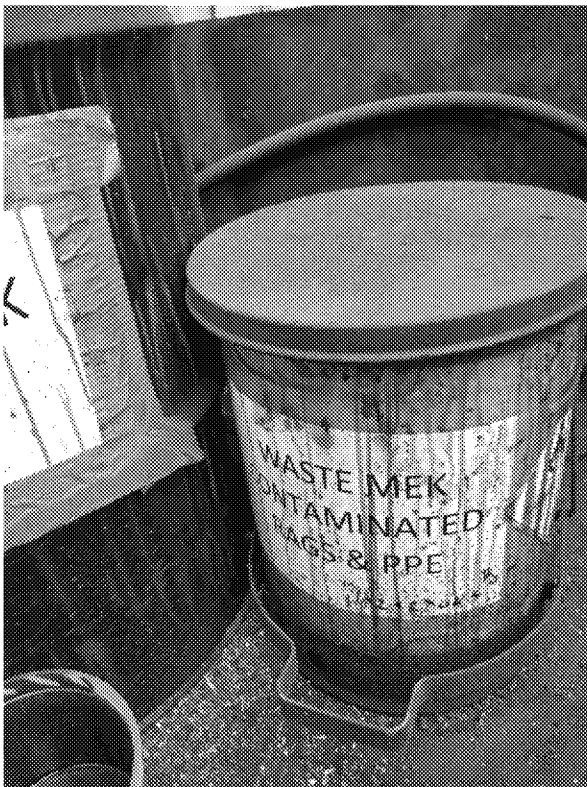
Photograph #20: improperly labeled satellite accumulation container in the paint mixing room
